RE: **Project # AE180001 WavCS**
Total Maximum Daily Load (TMDL) Sampling Report
Administration Building

TMDL Screening Inspection Log

Administration Building Waverly Community Schools		Date:	04/8/2013
		Drawn by:	JOF

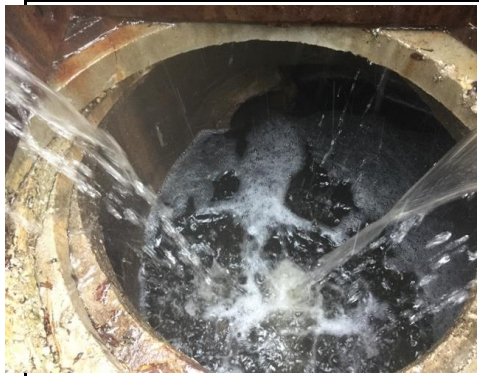
Structure Information:					
ID Number:	ADN-02.CB.DP	Structure Type:	Catch Basin	Lat:	42.727664 N
Type:	Discharge Point	Location:	Southwest corner of building on northern curb.		
Outfall Dimensions	10"			Long:	84.621356 W

Observations:					
Standing Water Characteristics			Flow Characteristics		
Standing Water:	Yes	Flow Observed:	Yes, Continous		
Color:	Clear	Source of Flow:	Inlet pipes and parking lot		
Odor:	No	Velocity of Flow:	Substantial		
Suds:	No	Color of Flow:	Clear		
Staining:	No	Flow Odor:	No		
Oil Sheen:	No				
Sewage:	No				
Bacterial Sheen:	No				
Algae:	No				
Slimes:	No				
Abnormal Growth:	No				
		Additional Comments:	N/A

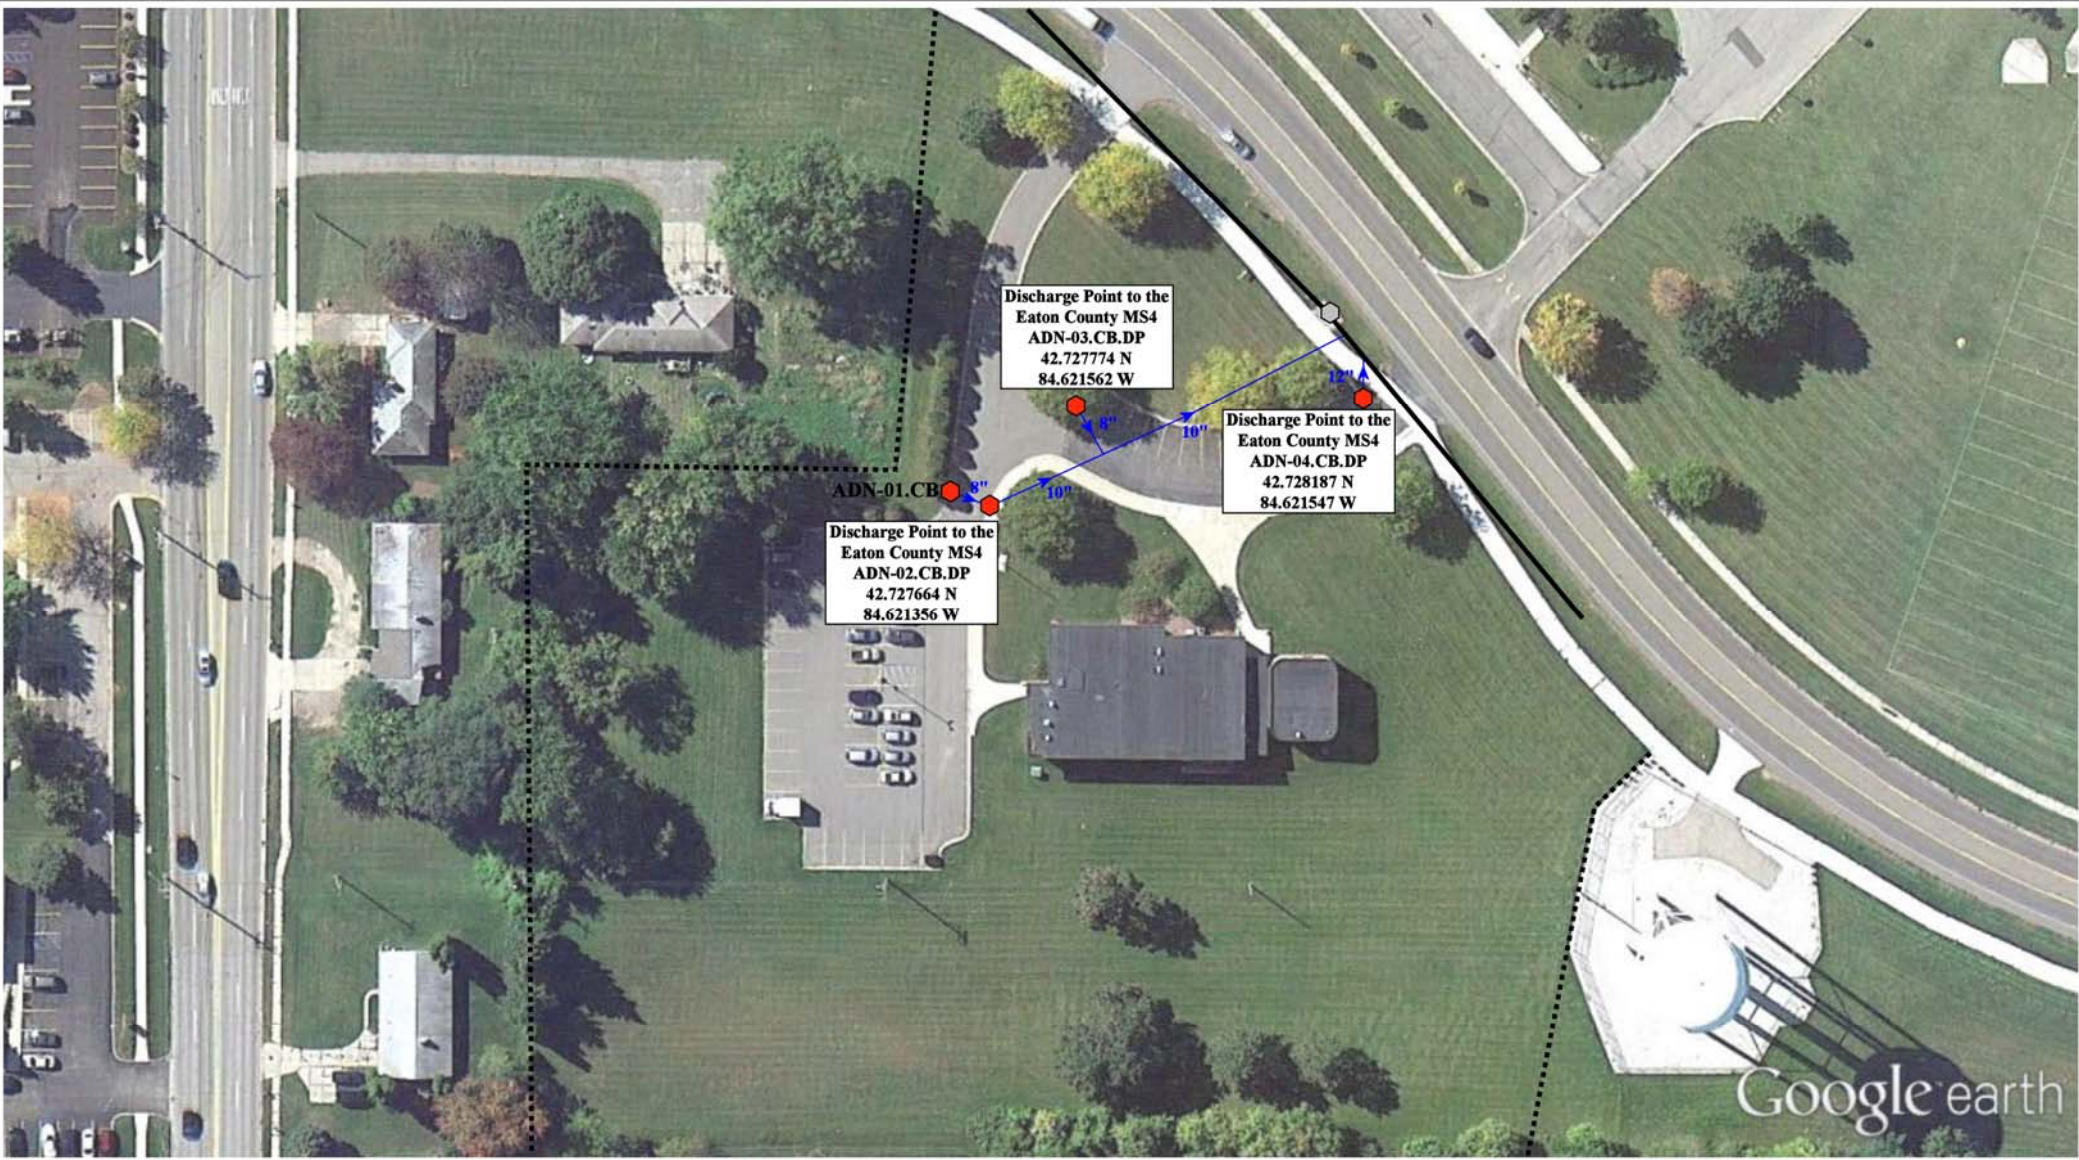
- = Catch Basin
- = Eaton County MS4
- = Property Line
