RE: **Project # AE180001 WavCS**
Total Maximum Daily Load (TMDL) Sampling Report
Colt Elementary School

TMDL Screening Inspection Log

Colt Elementary School

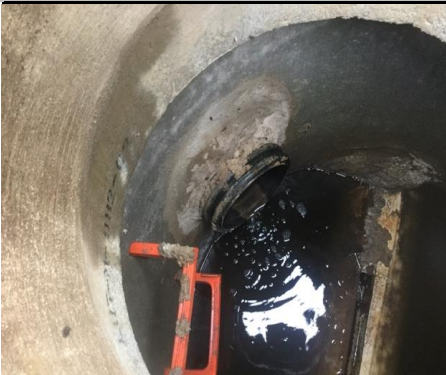
At the time of the sampling, clear water flow was noted, and CLT-07.CB.DP was free of odors, and abnormal vegetative growth. AEG collected a grab sample from CLT-07.CB.DP and the sample was screened for temperature and pH in the field. An E. coli grab sample was delivered to an external laboratory for analysis. Results from the sampling are summarized below. A more detailed TMDL Screening Inspection Log is also attached at the end of the report.

The sample results for CLT-07.CB.DP did not identify elevated levels of pH or E. coli above the TMDL Benchmark Standards. The reported levels for E. coli (26.2 CFU) are below the Michigan Public Health Department standards for Total Body Contact (E. coli >300 CFU).

Structure Information:					
ID Number:	CLT-07.CB.DP	Structure Type	Catch Basin	Lat:	42.735526 N
Type:	Discharge Point	Location:	North of school, northeast corner of track.		
Outfall Dimensions	10"			Long:	84.610610 W

Observations:					
Standing Water Characteristics			Flow Characteristics		
Standing Water:	Yes	Flow Observed:	Yes, Continous		
Color:	Clear	Source of Flow:	Inlet pipe		
Odor:	No	Velocity of Flow:	Slow		
Suds:	No	Color of Flow:	Clear		
Staining:	No	Flow Odor:	No		
Oil Sheen:	No				
Sewage:	No				
Bacterial Sheen:	No				
Algae:	No				
Slimes:	No				
Abnormal Growth:	No				
		Additional Comments:	N/A

Time Collected:	Temperature:	13.6	N/A	Celsius	
Last Rain Event:	E. coli:	26.2	300	CFU per 100mL	
Current Weather:	Total Phosphorus:	N/A	N/A	ug/L	
Screening Location Type:	Other:				
Total Rainfall (Inches):	Other:				
	Other:				
Outfall Characterization:	Unlikely				
Sample sent to Lab:	Yes

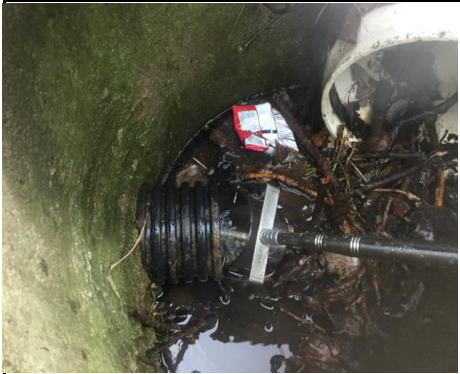
At the time of the sampling, clear water flow was noted, and CLT-08.MH.DP was free of odors, and abnormal vegetative growth. Sampled flow was coming from a field drain which drains the surrounding field/playground area. AEG collected a grab sample from CLT-08.MH.DP and the sample was screened for temperature and pH in the field. An E. coli grab sample was delivered to an external laboratory for analysis. Results from the sampling are summarized below. A more detailed TMDL Screening Inspection Log is also attached at the end of the report.

The sample results for CLT-08.MH.DP did not identify elevated levels of pH above the TMDL Benchmark Standards and the temperature was close in value to that of the sample collected at CLT-07.CB.DP. However, the highlighted value in the table above indicates that for discharge point CLT-08.MH.DP, the reported levels for E. coli (365.4 CFU) are slightly above the Michigan Public Health Department standards for Total Body Contact (E. coli >300 CFU).

flow in CLT-08.MH.DP was from a field drain which drains the surrounding field/playground area. Geese and other wildlife feces are likely the contributor to the slightly elevated E. coli levels. There are no signs of an illicit connection and no other pipes besides the field drain and sheet flow from the grassy field enter this basin.

Structure Information:					
ID Number:	CLT-08.MH.DP	Structure Type	Manhole	Lat:	42.735455 N
Type:	Discharge Point	Location:	Northeast corner of property in the grass.		
Outfall Dimensions	10"

Observations:					
Standing Water Characteristics			Flow Characteristics		
Standing Water:	Yes	Flow Observed:	Yes, Trickle		
Color:	Clear	Source of Flow:	Field drain		
Odor:	No	Velocity of Flow:	Trickle		
Suds:	No	Color of Flow:	Clear		
Staining:	No	Flow Odor:	No		
Oil Sheen:	No				
Sewage:	No				
Bacterial Sheen:	No				
Algae:	No				
Slimes:	No				
Abnormal Growth:	No				
		Additional Comments:	Sampled flow was coming from a field drain which drains the surrounding field/playground area. Geese and other wildlife feces are likely the contributor to the slightly elevated E. coli levels. There are no signs of an illicit connection and no other pipes besides the field drain and sheet flow from the grassy field enter this basin.

Time Collected:	12:00 PM	Temperature:	14.7	N/A	Celsius	
Last Rain Event:	> 72 Hours	E. coli:	365.4	300	CFU per 100mL	
Current Weather:	Rain	Total Phosphorus:	N/A	N/A	ug/L	
Sample Location Type:	Manhole	Other:				
Total Rainfall (Inches):	.57	Other:				
Other:		Other:				
Outfall Characterization:	Unlikely					
Sample sent to Lab:	Yes

Arch Environmental Group, Inc. recommends that the elevated location CLT-08.MH.DP be re-assessed each permit cycle to ascertain whether greater or reduced potential for E. coli TMDL contribution has occurred. Geese, gulls and ducks are speculated to be a major bacterial source in urban areas, particularly where large populations congregate. E. coli (*Escherichia Coli*) is a sub-group of the fecal coliform group and can be used as an indicator of fecal contamination. E. coli bacteria exist in animal and human fecal matter.³ Elevated levels of E. coli can occur at sites which have populations of wild or domesticated animals. E. coli originating from birds, raccoons and other wildlife may be present in large numbers in stormwater runoff. In an effort to determine the cause of the benchmark exceedance of E. coli, Arch Environmental Group reviewed the layout of the school storm water system as well as past tracer dye studies. Based on this investigation, sanitary sewer contamination from Colt Elementary School is not suspected. The source is likely natural sources, such as the presence of wild animals from the stormwater runoff of the surrounding grassy field.
