RE: **Project # AE180001 WavCS**
Total Maximum Daily Load (TMDL) Sampling Report
East Intermediate School

TMDL Screening Inspection Log

East Intermediate School

Waverly Community Schools

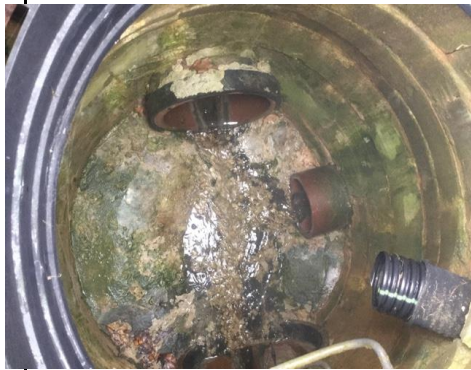
Structure Information:					
ID Number:	WEL-01.MH.DP	Structure Type:	Manhole	Lat:	42.733012 N
Type:	Discharge Point	Location:	Northeast of main entrance in the grass next to sidewalk.		
Outfall Dimensions	24"			Long:	84.591310 W

At the time of the sampling, clear water flow was noted, and WEL-01.MH.DP was free of odors, and abnormal vegetative growth. AEG collected a grab sample from WEL-01.MH.DP and the sample was screened for temperature and pH in the field. An E. coli grab sample was delivered to an external laboratory for analysis. Results from the sampling are summarized below. A more detailed TMDL Screening Inspection Log is also attached at the end of the report.

Observations:					
Standing Water Characteristics			Flow Characteristics		
Standing Water:	Yes	Flow Observed:	Yes, Continous		
Color:	Clear	Source of Flow:	Inlet pipe		
Odor:	No	Velocity of Flow:	Substantial		
Suds:	No	Color of Flow:	Clear		
Staining:	No	Flow Odor:	No		
Oil Sheen:	No				
Sewage:	No				
Bacterial Sheen:	No	Additional Comments:	N/A		
Algae:	No				
Slimes:	No				
Abnormal Growth:	No

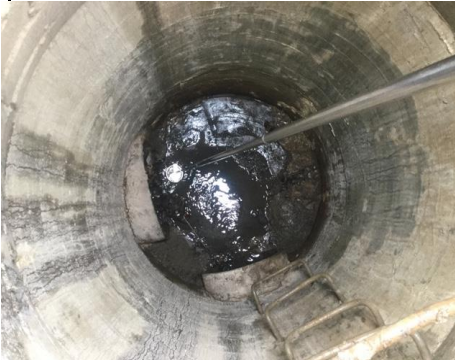
Structure Information:					
ID Number:	WEL-07.MH.DP	Structure Type	Manhole	Lat:	42.733514 N
Type:	Discharge Point	Location:	East of east entry drive in the grass southeast of sidewalk.		
Outfall Dimensions	24"

At the time of the sampling, clear water flow was noted, and WEL-07.MH.DP was free of odors, and abnormal vegetative growth. AEG collected a grab sample from WEL-07.MH.DP and the sample was screened for temperature and pH in the field. An E. coli grab sample was delivered to an external laboratory for analysis. Results from the sampling are summarized below. A more detailed TMDL Screening Inspection Log is also attached at the end of the report.

Observations:					
Standing Water Characteristics			Flow Characteristics		
Standing Water:	Yes	Flow Observed:	Yes, Continous		
Color:	Clear	Source of Flow:	Inlet pipe		
Odor:	No	Velocity of Flow:	Moderate		
Suds:	No	Color of Flow:	Clear		
Staining:	No	Flow Odor:	No		
Oil Sheen:	No	Additional Comments: N/A			
Sewage:	No				
Bacterial Sheen:	No				
Algae:	No				
Slimes:	No				
Abnormal Growth:	No
