RE: **Project # AE180001 WavCS**
Total Maximum Daily Load (TMDL) Sampling Report
Transportation & Maintenance Center

RE: **AEG Project # AE170001 WavCS**
Dry Weather Field Screening
Transportation & Maintenance Facility

DRY WEATHER FIELD SCREENING REPORT

Transportation & Maintenance Facility

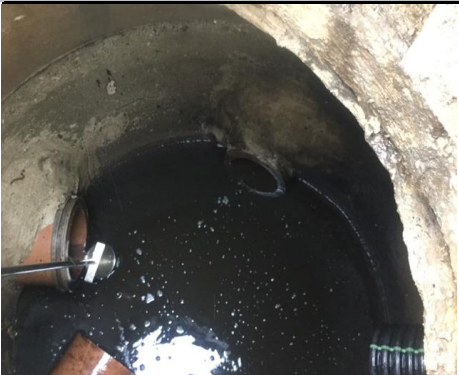
Sample ID And Information	Lab Analysis:	Results:	TMDL Threshold:	Units:	Photo ID:
Sample ID:	pH:	8.1	6.5 - 9	pH units

Structure Information:					
ID Number:	WTM-01.CB.DP	Structure Type	Catch Basin	Lat:	42.726328 N
Type:	Discharge Point	Location:	Northeast of building near entrance on pavement.		
Outfall Dimensions	8"			Long:	84.600891 W

Observations:					
Standing Water Characteristics			Flow Characteristics		
Standing Water:	Yes	Flow Observed:	Yes, Trickle		
Color:	Clear	Source of Flow:	Inlet pipe		
Odor:	No	Velocity of Flow:	Trickle		
Suds:	No	Color of Flow:	Clear		
Staining:	No	Flow Odor:	No		
Oil Sheen:	No				
Sewage:	No				
Bacterial Sheen:	No				
Algae:	No				
Slimes:	No				
Abnormal Growth:	No				
			Additional Comments:		
			Sampled flow was coming from the pipes connected to upstream basins and from sheet flow on the surrounding pavement. Geese and other wildlife feces are likely the contributor to the slightly elevated E. coli levels. In 2013, the floor drains in the bus wash bay and mechanic bay were dye traced and confirmed that they are not illicitly connected to the stormwater system.

Time Collected:	Temperature:	20.2	N/A	Celsius	
Last Rain Event:	E. coli:	579.4	300	CFU per 100mL	
Current Weather:	Total Phosphorus:	N/A	N/A	ug/L	
Screening Location Type:	Other:				
Total Rainfall (Inches):	Other:				
	Other:				
Outfall Characterization:	Unlikely				
Sample sent to Lab:	Yes

Arch Environmental Group, Inc. recommends that the elevated location WTM-01.CB.DP be re-assessed each permit cycle to ascertain whether greater or reduced potential for E. coli TMDL contribution has occurred. Geese, gulls and ducks are speculated to be a major bacterial source in urban areas, particularly where large populations congregate. E. coli (*Escherichia Coli*) is a sub-group of the fecal coliform group and can be used as an indicator of fecal contamination.³ Elevated levels of E. coli typically occur at sites which have leaking sanitary sewer systems, failed septic systems, or populations of wild or domesticated animals. E. coli originating from birds, raccoons and other wildlife may be present in large numbers in stormwater runoff. In an effort to determine the cause of the benchmark exceedance of E. coli, Arch Environmental Group reviewed the layout of the school storm water system as well as past tracer dye studies from 2013. Based on this investigation, sanitary sewer contamination from the Transportation & Maintenance Center is not suspected. The most recent Dry Weather Screening inspection conducted on October 3, 2017 at the Transportation & Maintenance Center did not identify any signs of an illicit connection at this facility. The Dry Weather Screening report is attached. The source is likely natural sources, such as the presence of wild animals from the stormwater runoff of the surrounding pavement.

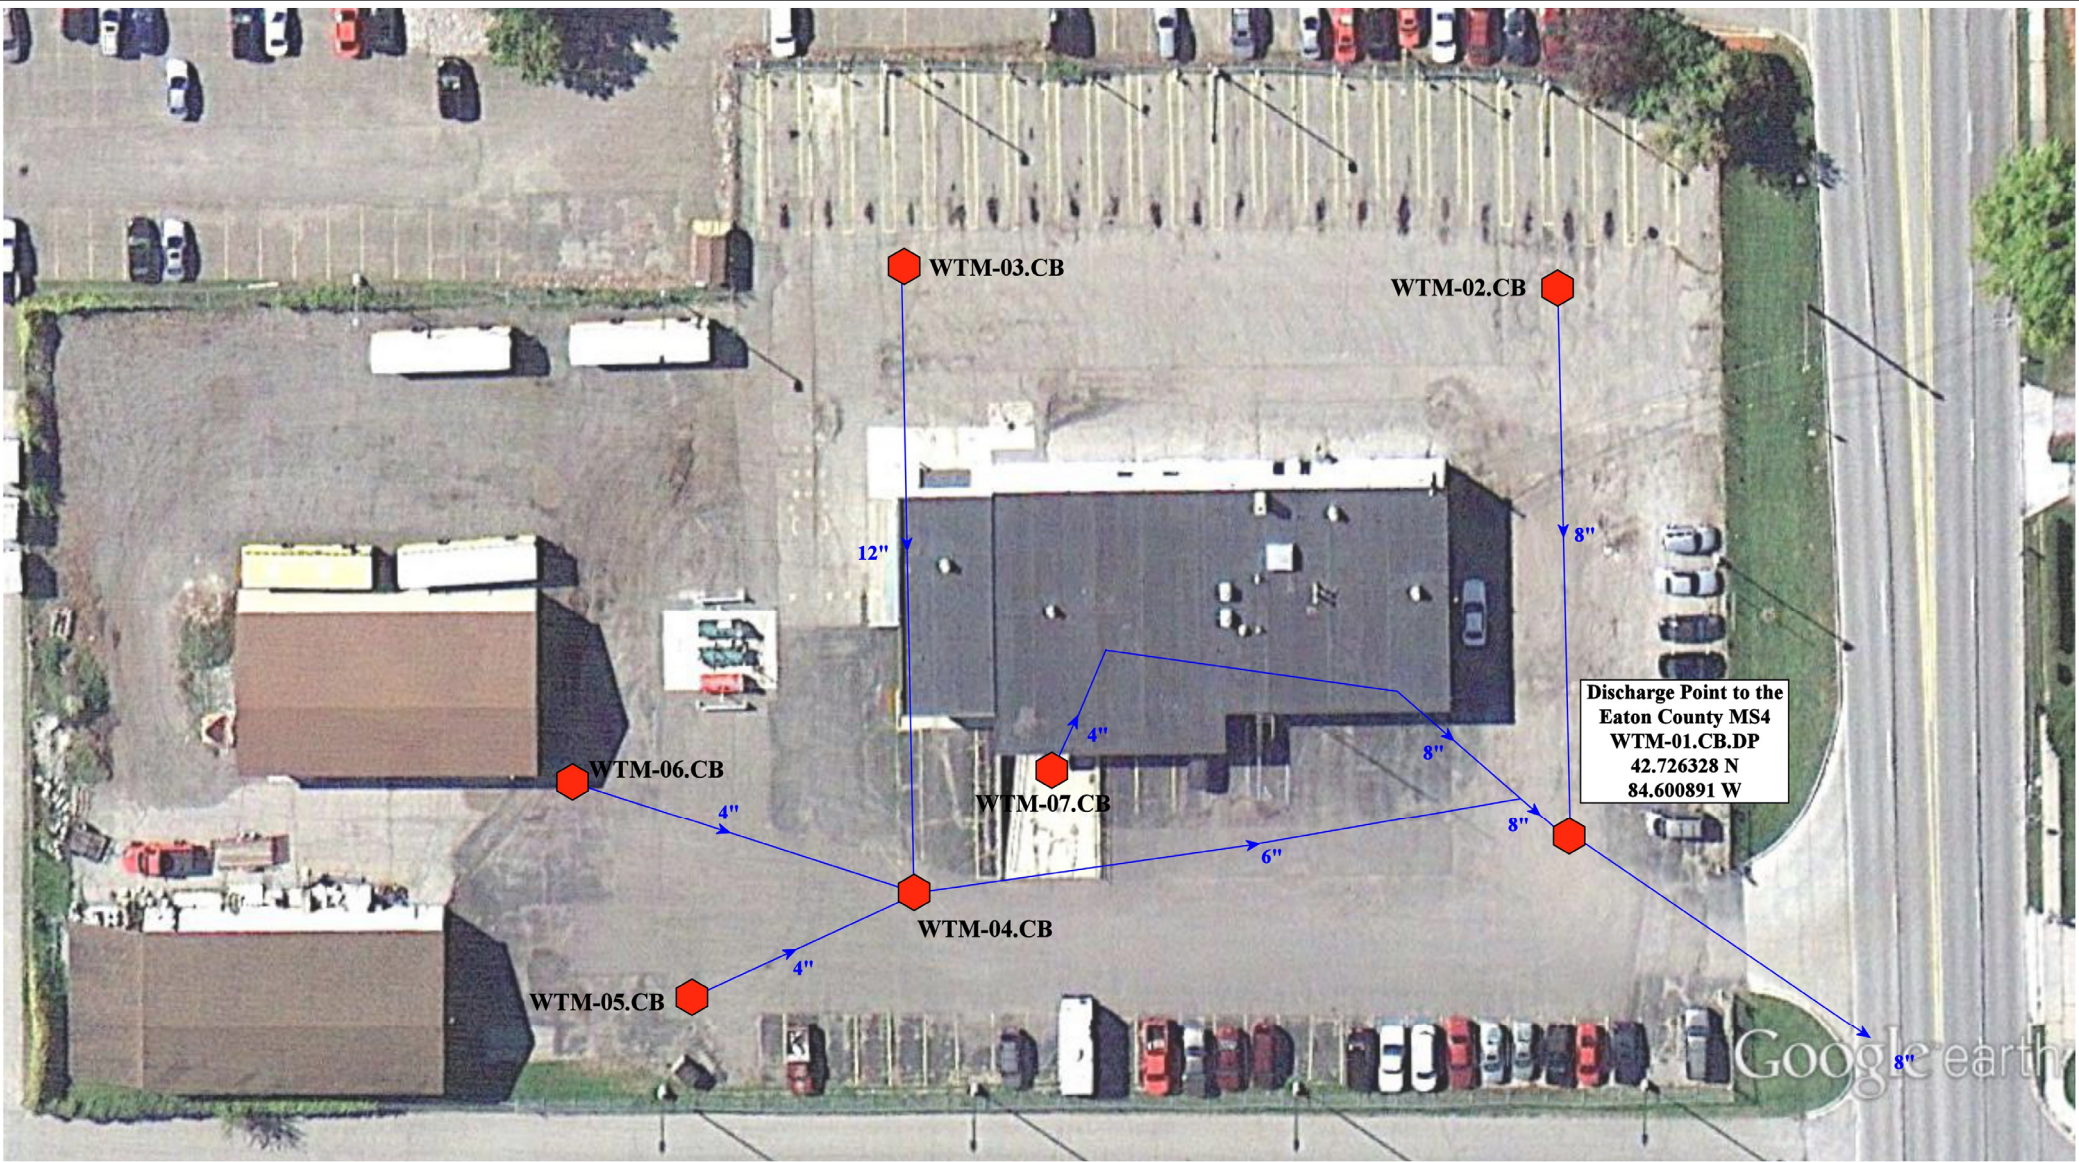
Transportation & Maintenance Center

= Catch Basin

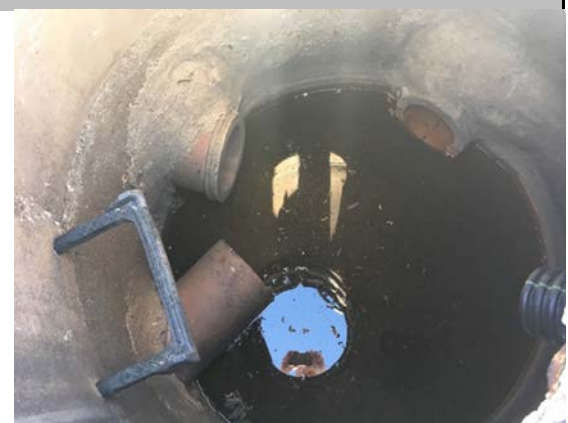
Photo ID:

ID Number:	WMT-01.CB.DP	Structure Type	Catch Basin	Lat:	42.726328	Long:	84.600891
Type:	Discharge Point	Location:	Northeast corner of the building, south of then fence, west of the main driveway entrance in the parking lot.				
Outfall Dimensions	8"

Standing Water:	Yes
Color:	Clear
Odor:	No
Suds:	No
Staining:	No
Oil Sheen:	No
Sewage:	No
Bacterial Sheen:	No
Algae:	No
Slimes:	No
Abnormal Growth:	No

Flow Observed:	No
Source of Flow:	N/A
Velocity of Flow:	N/A
Color of Flow:	N/A
Flow Odor	N/A

Cleaning:	No
Blockages	No
Structural Issues	None
Structural Trend	Stable
Stenciling:	No

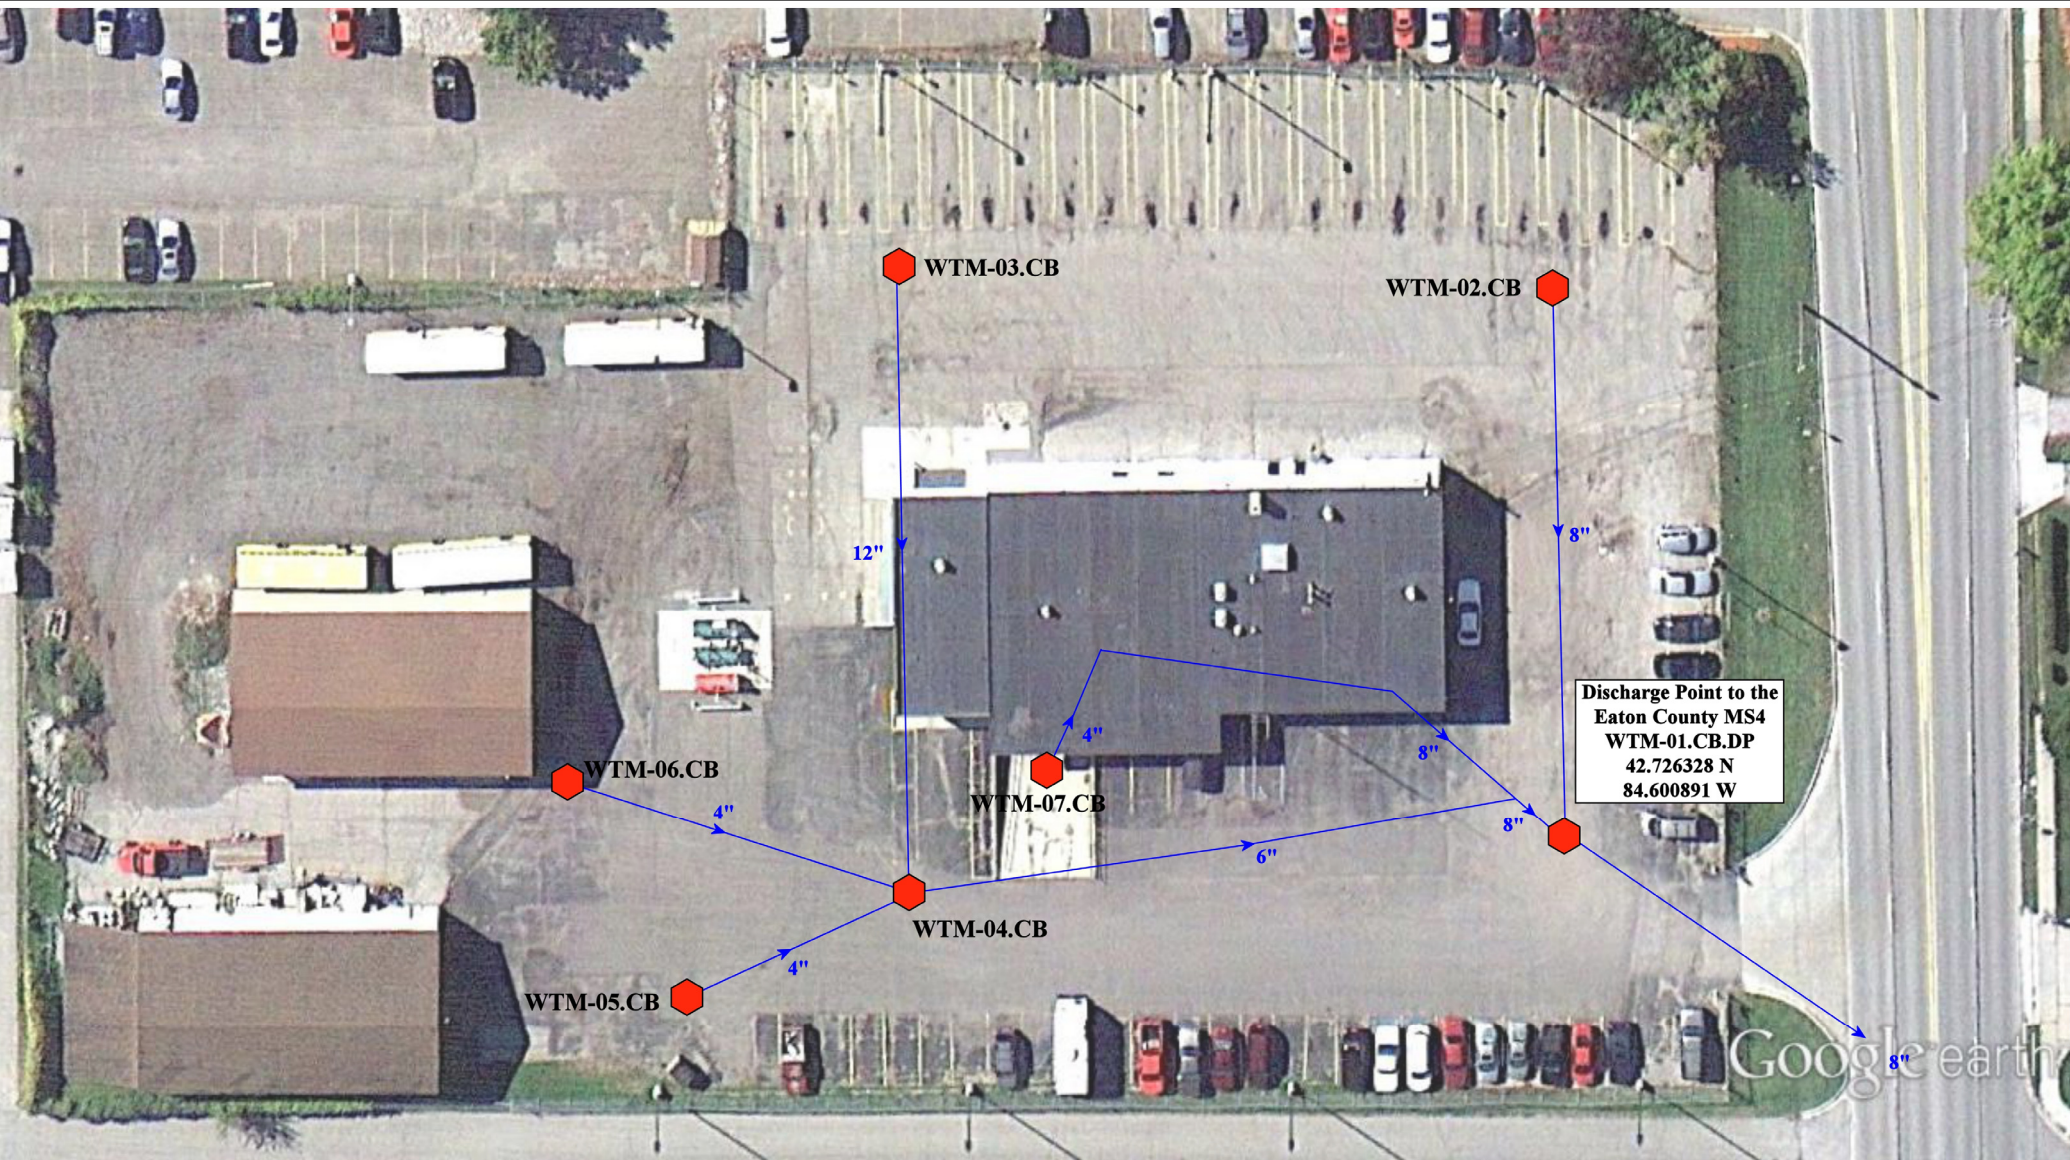
APPENDIX B
Storm Sewer System Site Map

= Catch Basin
