RE: **Project # AE180001 WavCS**
Total Maximum Daily Load (TMDL) Sampling Report
Elmwood Elementary School

TMDL Screening Inspection Log

Elmwood Elementary School

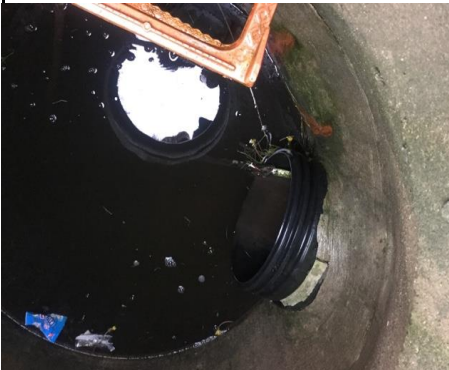
Structure Information:					
ID Number:	EWD-05.CB.DP	Structure Type:	Catch Basin	Lat:	42.753683 N
Type:	Discharge Point	Location:	Along west property line, west of northeast corner of parking lot.		
Outfall Dimensions	6"			Long:	84.624155 W

Observations:					
Standing Water Characteristics			Flow Characteristics		
Standing Water:	Yes	Flow Observed:	Yes, Continous		
Color:	Clear	Source of Flow:	Inlet pipe		
Odor:	No	Velocity of Flow:	Slow		
Suds:	No	Color of Flow:	Clear		
Staining:	No	Flow Odor:	Yes		
Oil Sheen:	No				
Sewage:	No				
Bacterial Sheen:	No				
Algae:	No				
Slimes:	No				
Abnormal Growth:	No				
		Additional Comments:	N/A
