RE: **Project # AE180001 WavCS**
Total Maximum Daily Load (TMDL) Sampling Report
Waverly High School Complex

Arch Environmental Group, Inc. recently conducted a round of TMDL Wet Weather Sampling at discharge point WVC-03.MH.DP at the Waverly High School Complex on May 3, 2018, in accordance with the applicable NPDES Permit requirements. TMDL sampling is used to determine the level of specific pollutants in the stormwater system by collecting samples from 50% of the district's stormwater outfalls/discharge points during a representative wet weather event. The sampling results are then evaluated to determine if a particular point source needs to be addressed to reduce the pollutant load of the receiving waters. A report regarding the findings of this round of TMDL Sampling is attached.

TMDL Screening Inspection Log

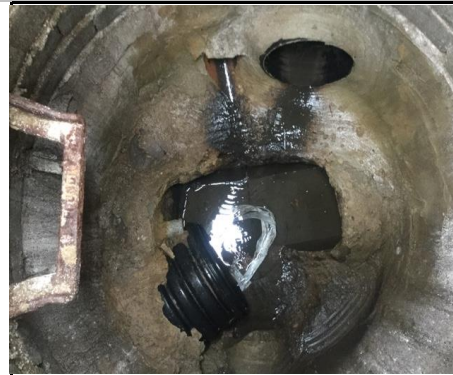
Structure Information:							
ID Number:	WVC-03.MH.DP	Structure Type	Manhole	Lat:	42.733434 N	Long:	84.625993 W
Type:	Discharge Point	Location:	North of Winans Elementary between the two parking lots in the grass.				
Outfall Dimensions	18"

Observations:							
Standing Water Characteristics				Flow Characteristics			
Standing Water:	Yes	Flow Observed:	Yes, Continuous				
Color:	Clear	Source of Flow:	Multiple outlet pipes				
Odor:	No	Velocity of Flow:	Slow				
Suds:	No	Color of Flow:	Clear				
Staining:	No	Flow Odor	No				
Oil Sheen:	No	Additional Comments: N/A					
Sewage:	No						
Bacterial Sheen:	No						
Algae:	No						
Slimes:	No						
Abnormal Growth:	No
